# KT24A/28A/30A/32A/36A/40A

# Repair Manual

# KT24A/28A/30A/32A/36A/40A SERIES

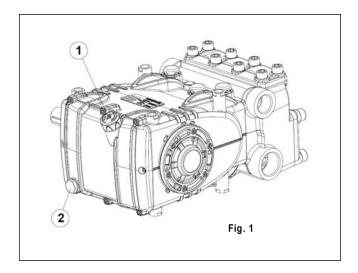
Mechanical parts repair must be performed after removal of oil from the casing. To drain the oil, remove the oil dipstick, (1, fig. 1) and then the draining plug (2, fig. 1).

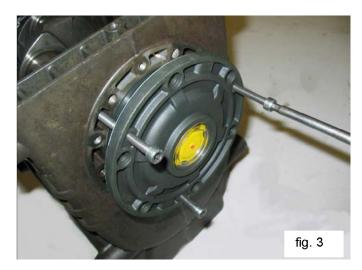
- The side covers using - for extraction 3 fully threaded M6 x 50 screws, inserting them in the threaded holes as indicated in fig. 3

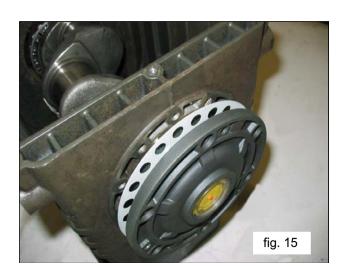
Once the type and number of shims have been determined using the table, check the following: assemble the shim pack on the indicator side cover centering (fig. 15), secure the cover to the casing, following the procedure in paragraph 2.1.2 and tighten the screws to their recommended torque. Check that the shaft rotation stall torque is between 3-4.5 Ft. Lbs.(4-6 Nm). If this torque is correct, connect the con-rods to the crankshaft and to the next stages. If it is not, redefine the shim pack, repeat the operations.

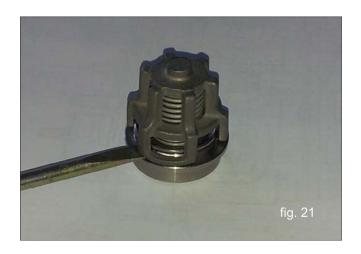
Dismantling of the suction and outlet valve units can be carried out screwing in a sufficiently long M10 screw which can move the valve plate and remove the valve guide from the seat (1, fig. 20). If the threaded holes should not be present on the valve guides, dismantling can be easily carried out by leveraging with simple tools (fig 21).

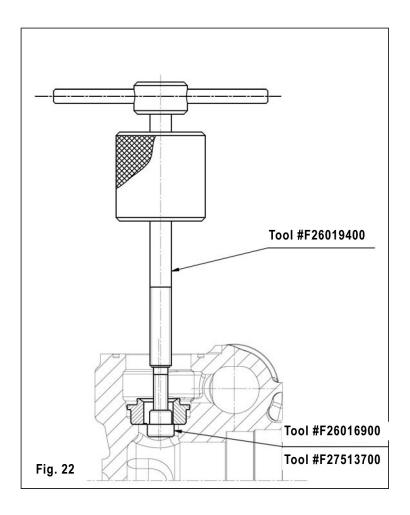
For KT24A, 28A, 30A, 32A use tools #F26019400, and F27513700 (fig. 22)

For KT36A and 40A use tools #F26019400, F27516900 (fig. 22)

For KT36A and 40A use tools #F26019400 and F27513700 (fig 22)

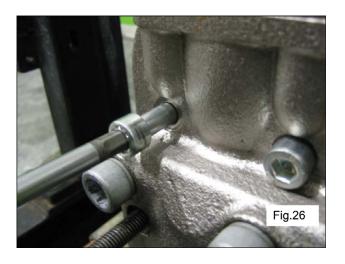
A) Unscrew the M10x110 head fixing screw as indicated in fig. 26.

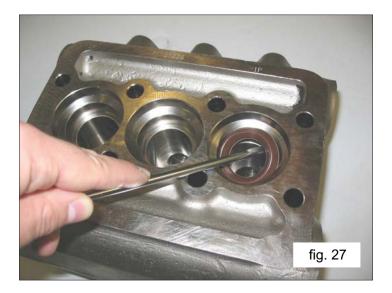
- B) Separate the head from the pump casing.
- C) Extract the high pressure seals from the head and the low pressure ones from the support, using simple tools as indicated in fig. 27, being careful not to damage the respective housings.

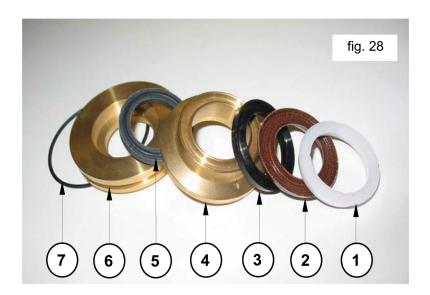
Pay attention to the order of seal pack disassembly as indicated in fig. 28 composed of:

- 1. Head ring
- 2. HP seal
- 3. Restop ring
- 4. Seals support
- 5. LP seal
- 6. Seal ring
- 7. O-ring

- A) Seals pack Respect the same order used during disassembly operations.
- B) Lubricate components 2,3 and 5 with OCILIS silicone grease p/n F12001600; this operation is also deemed necessary to facilitate adjustment of the lip seal on the piston.

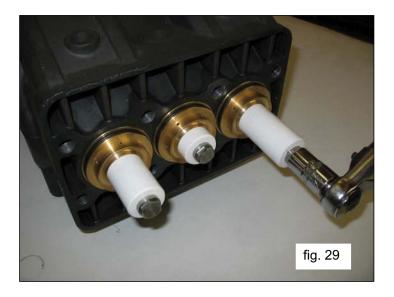
The piston unit does not require any routine maintenance. Maintenance is limited to visual checks only. To extract piston units: loosen the M7x1 piston fixing screws as indicated in fig. 29.

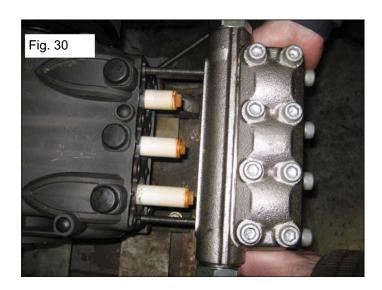
- 1. Position the seal support in the respective seats on the casing.
  - 2. Using two screws p/n F27726000, fasten the casing as indicated in fig. 30. Position the complete head, making sure that it is centered only on the central piston.

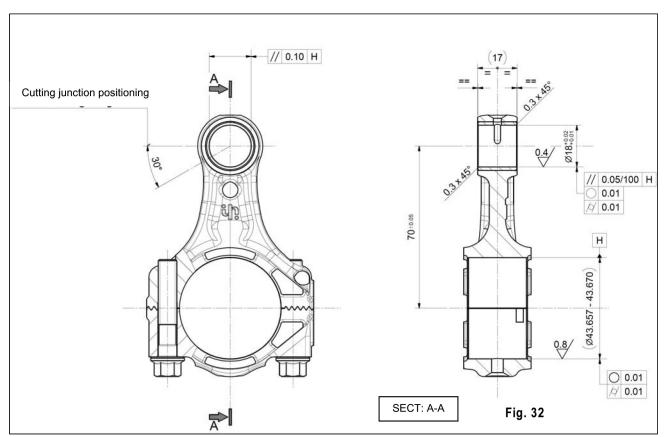
- the lubrication hole coincides with the corresponding hole on the con rod;
- the cutting junction is directed as shown in fig. 32.

Then perform mechanical processing. The dimensions and tolerances shown in fig. 32 MUST be respected.
